HAZARD ALERT

TRASH COMPACTOR FATALITY

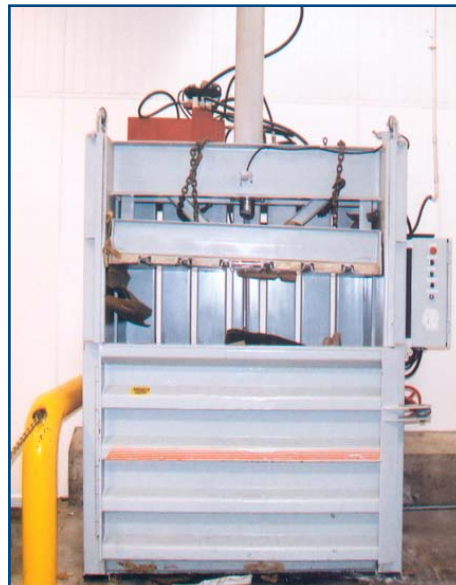
A 22-year-old worker sustained a fatal head injury while checking a vertical cardboard bale compactor. The feed gate was in the open position, and the ramming plate was in the raised position. It is believed that the victim heard a noise in the machine and put his head into the opening to investigate. The hydraulic cylinder, which held the ramming plate up in the air, broke off at the joint, causing the plate to slide down rapidly. The young worker's head was caught in between the plate and the top of the bale chamber door, causing immediate and fatal injuries.

The unit functioned in such a way that when cardboard was piled evenly in the chamber, the plate could come down and crush the cardboard without putting stress on the cylinder rod and connection pin. If, however, cardboard was not placed squarely in the middle of the chamber, when the plate was lowered, it compressed the cardboard unevenly, causing stress at the joints.

It was found that the vertical cylinder rod broke due to fatigue at the joint where the rod connected to the pin. Due to repeated bending of the ram during compression of

the uneven cardboard, there was excessive force on the connecting area, which led to a failure at the joint.

On several previous occasions, the ram became wedged sideways when compressing uneven loads, and a metal rod was used to pry it back into place.

The bale compactor was not certified nor designed by an engineer, and had been in service for only seven months at the time of the accident.

1. **Proper design:** A bale compactor must be designed using an established standard or code such as the ANSI standard Z245.51-2004 for Equipment Technology and Operations for waste and Recyclable Materials – Baling Equipment – Safety Requirements. The ram and cylinder in all bale compactors should be inspected regularly for any signs of wear. A secondary safeguard that holds the plate in the event of a cylinder failure or hydraulic fluid leak should be standard in the manufacturing of these units.

2. **Information:** The manufacturer must supply information regarding the proper installation, operation, and maintenance of the units.
3. **Training:** It is essential that employees be trained in proper procedures and maintenance of these units. All users must keep any part of their bodies out of the machine at all times, except to enter the unit to remove the bale. When it becomes necessary to remove the baled cardboard, there must be a means of blocking the plate so it cannot fall on the workers while they are inside.
